**1997 Thomas Built Bus  
into a Flat Frontal Barrier  
TRC Test Number: 990421-1**

**Prepared by:  
Transportation Research Center Inc.  
10820 State Route 347  
East Liberty, OH 43319**

**Final Report  
April - June 1999**

**Prepared For:  
Vehicle Research and Test Center  
P. O. Box 37  
East Liberty, OH 43319**

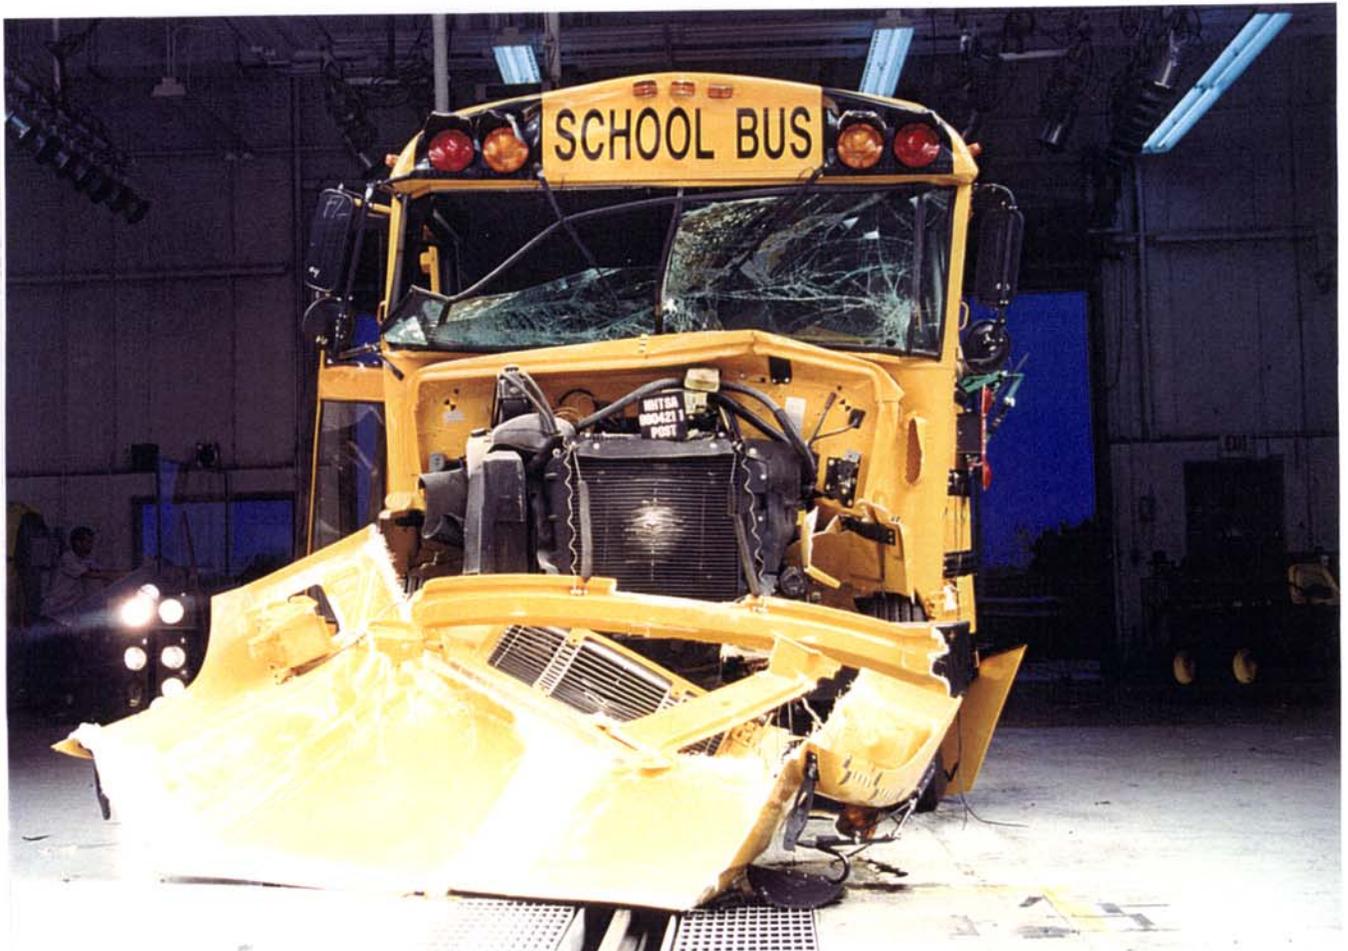
**Figure A-2 Post-Test Front View**

The test vehicle was a 1997 Thomas Built Bus. The vehicle's test weight was 17,760 pounds. The vehicle's impact speed was 30.0 mph. The vehicle's maximum static crush was 206 millimeters.

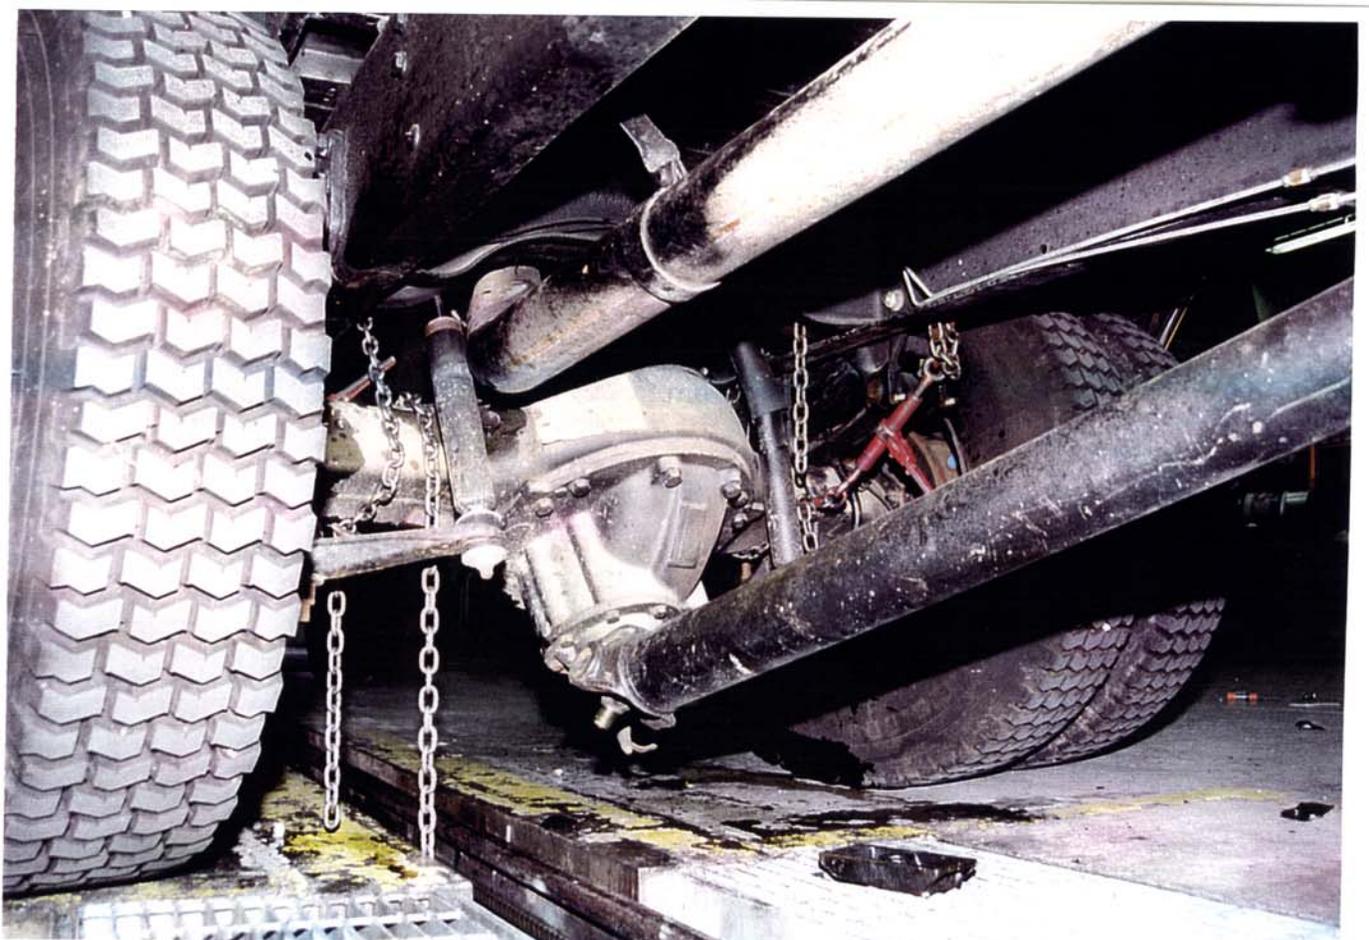
Figure A-66 Post-Test Miscellaneous Damage - View 1

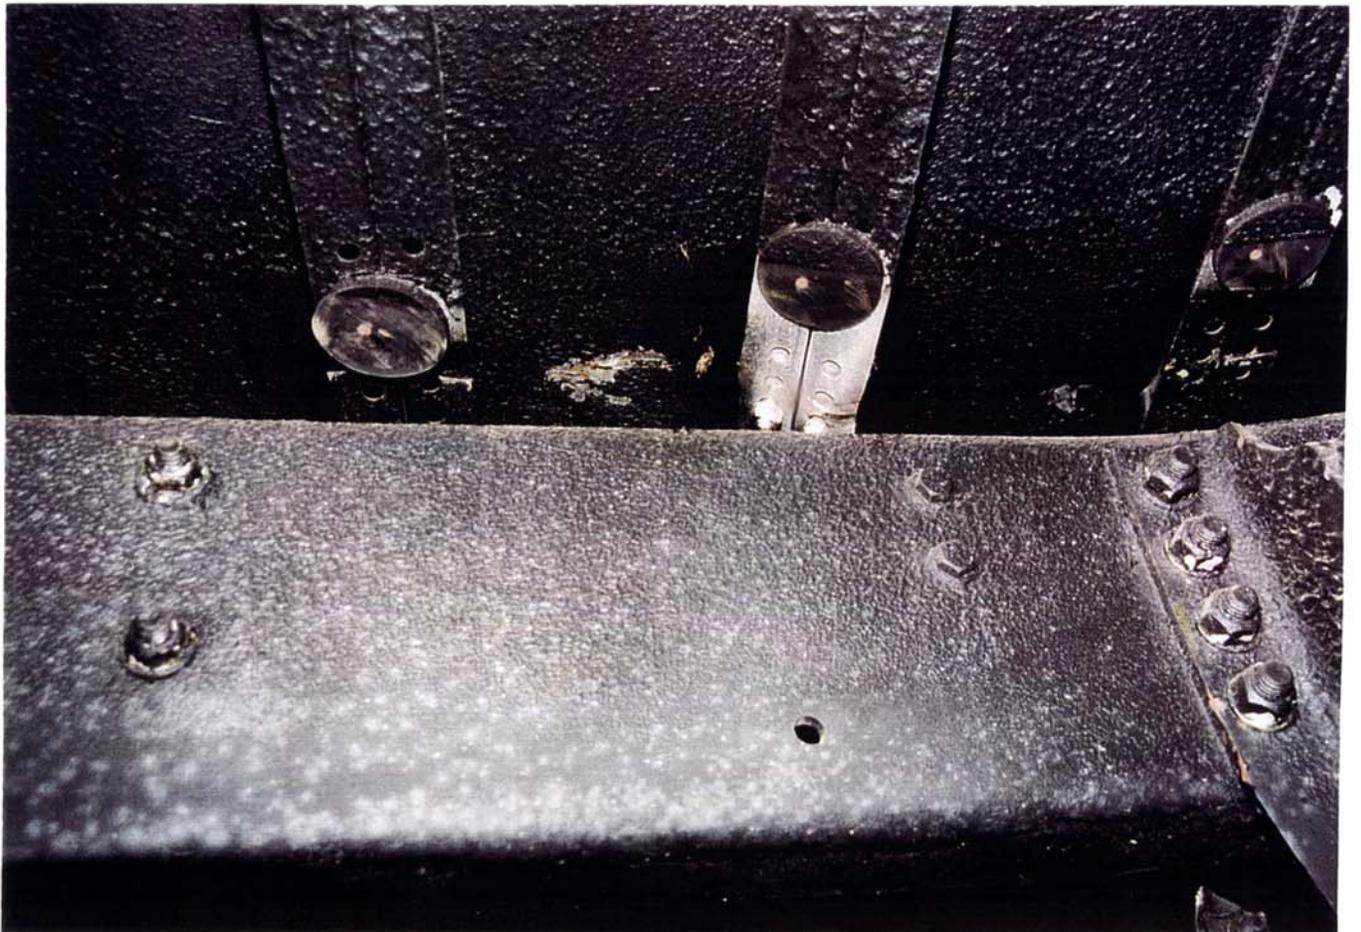
Figure A-67 Post-Test Miscellaneous Damage - View 2

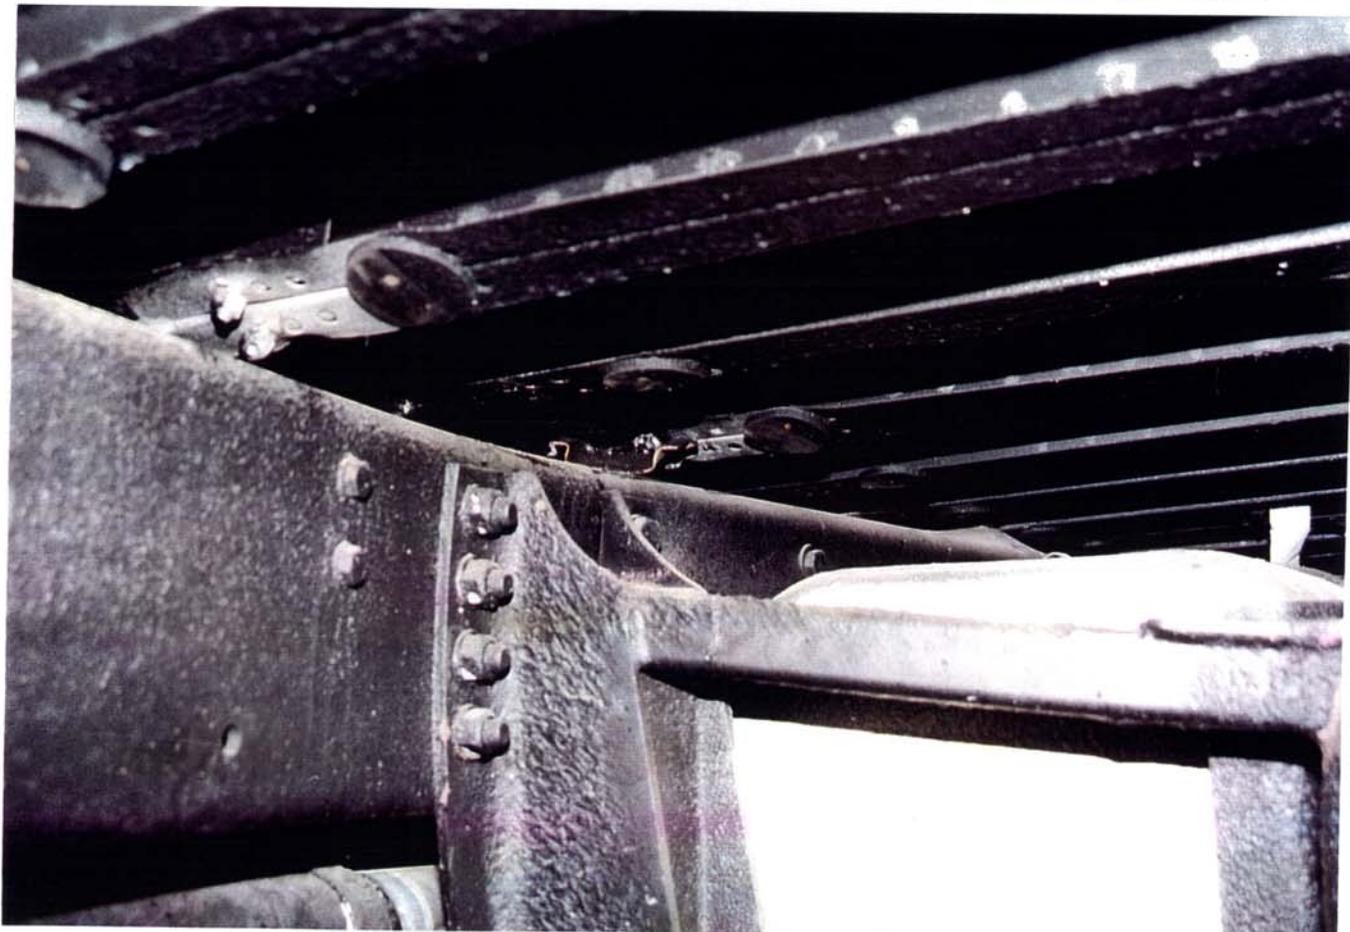
Figure A-68 Post-Test Miscellaneous Damage - View 3

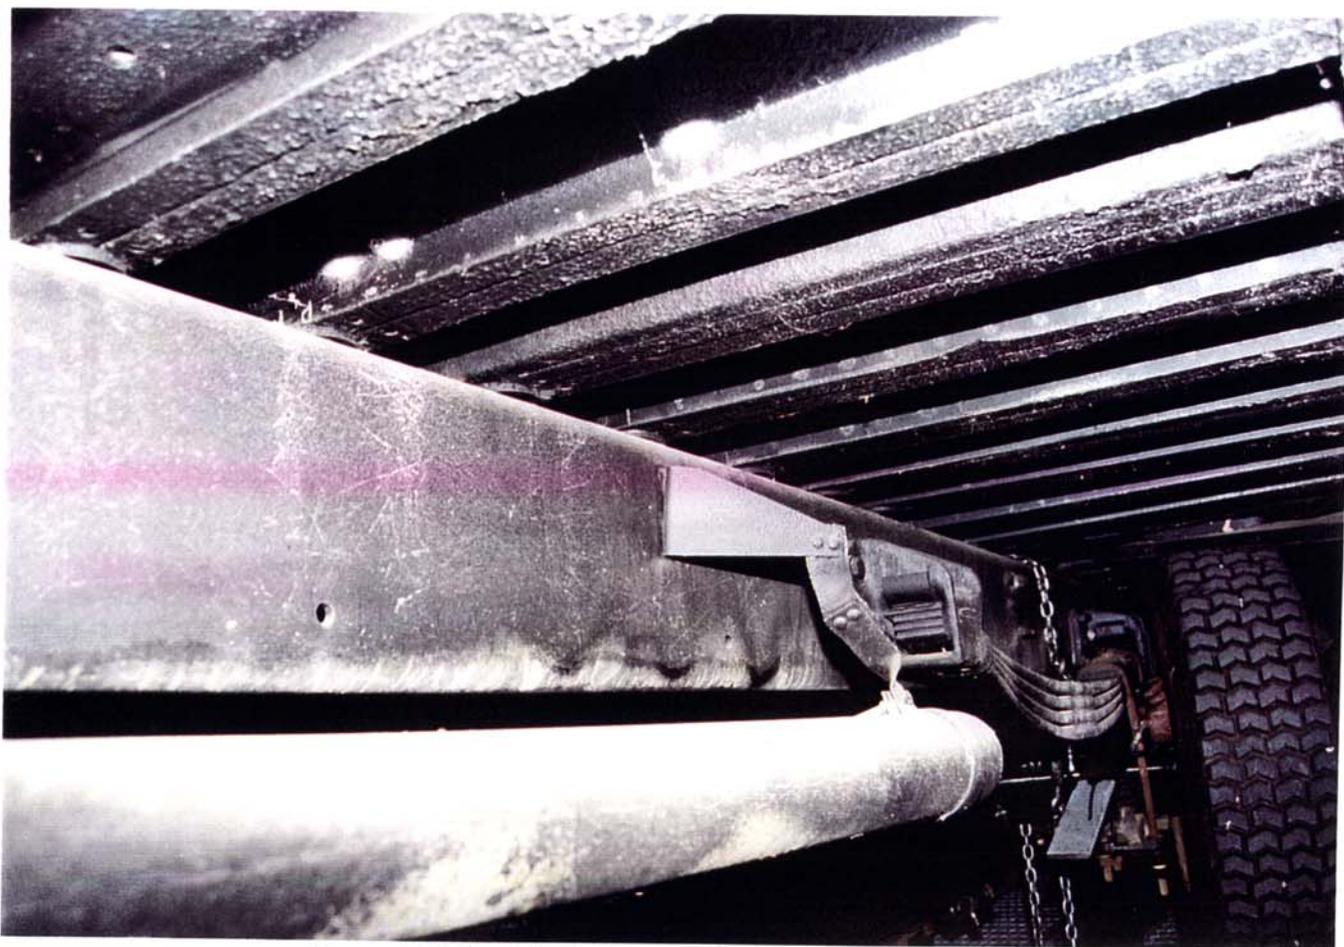
Figure A-69 Post-Test Miscellaneous Damage - View 4

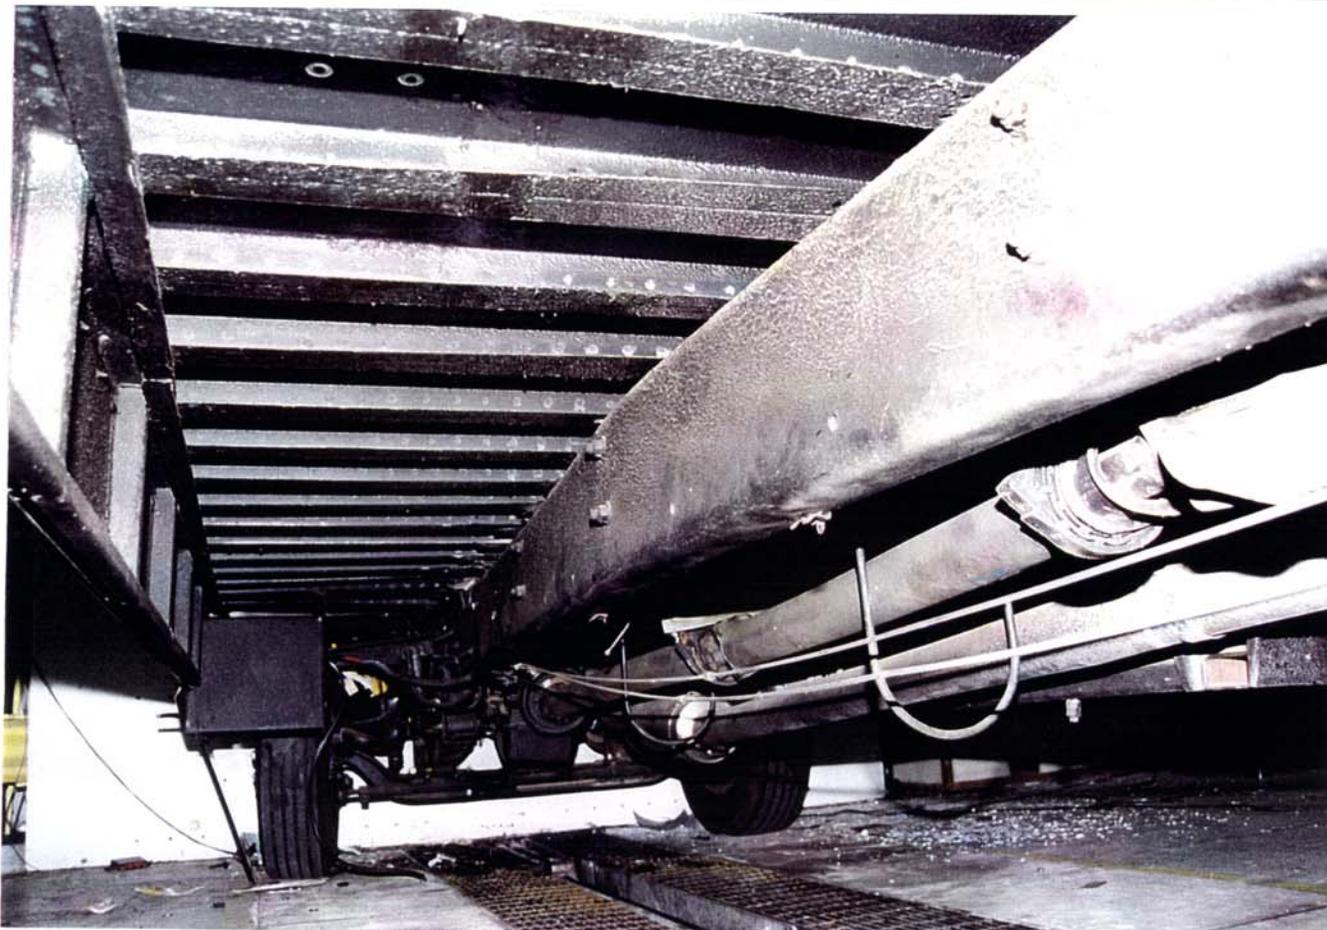
Figure A-70 Post-Test Miscellaneous Damage - View 5

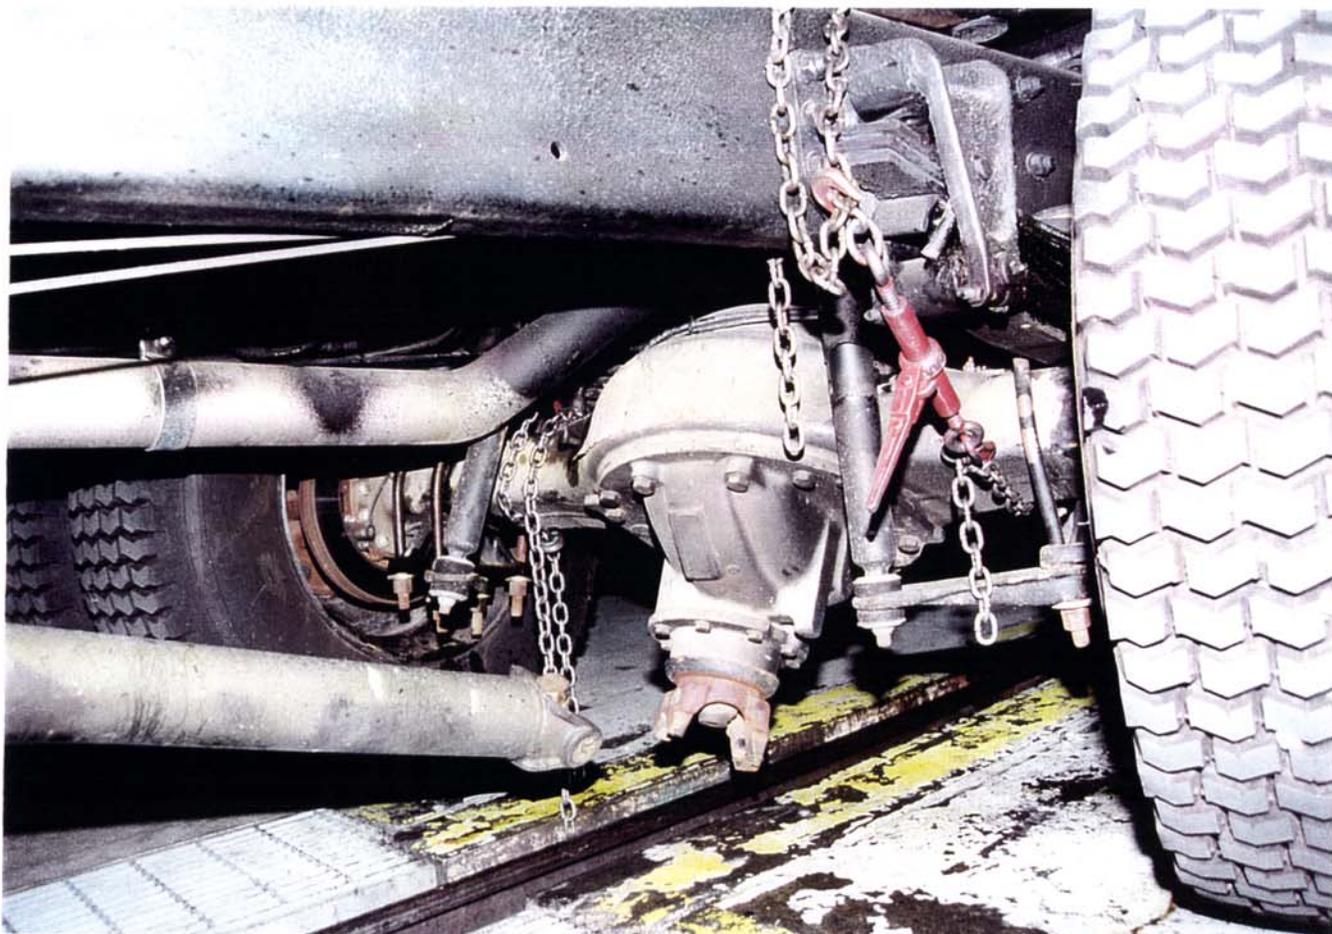
Figure A-71 Post-Test Miscellaneous Damage - View 6

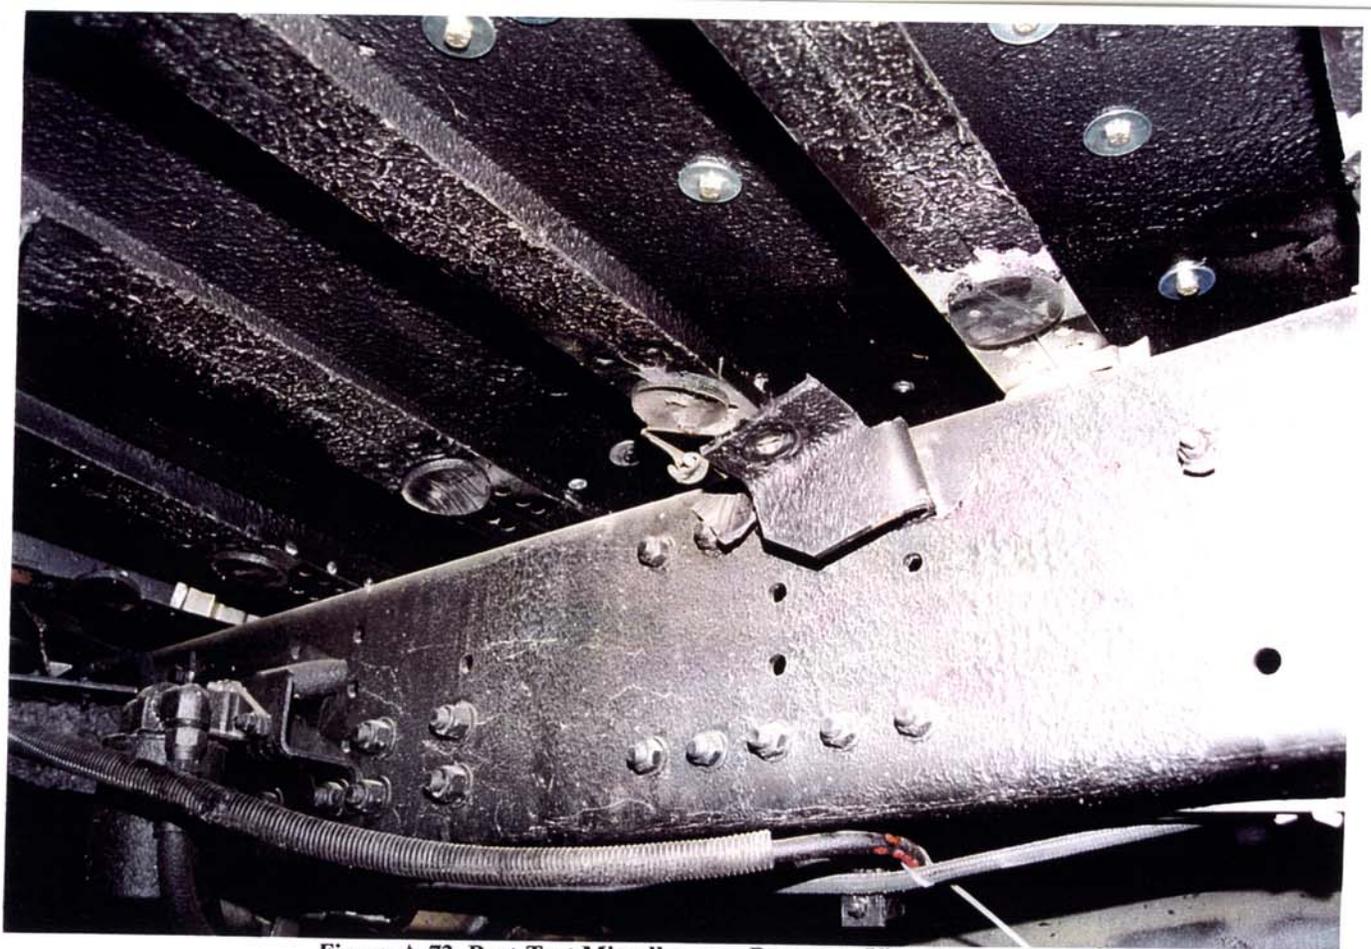
Figure A-72 Post-Test Miscellaneous Damage - View 7

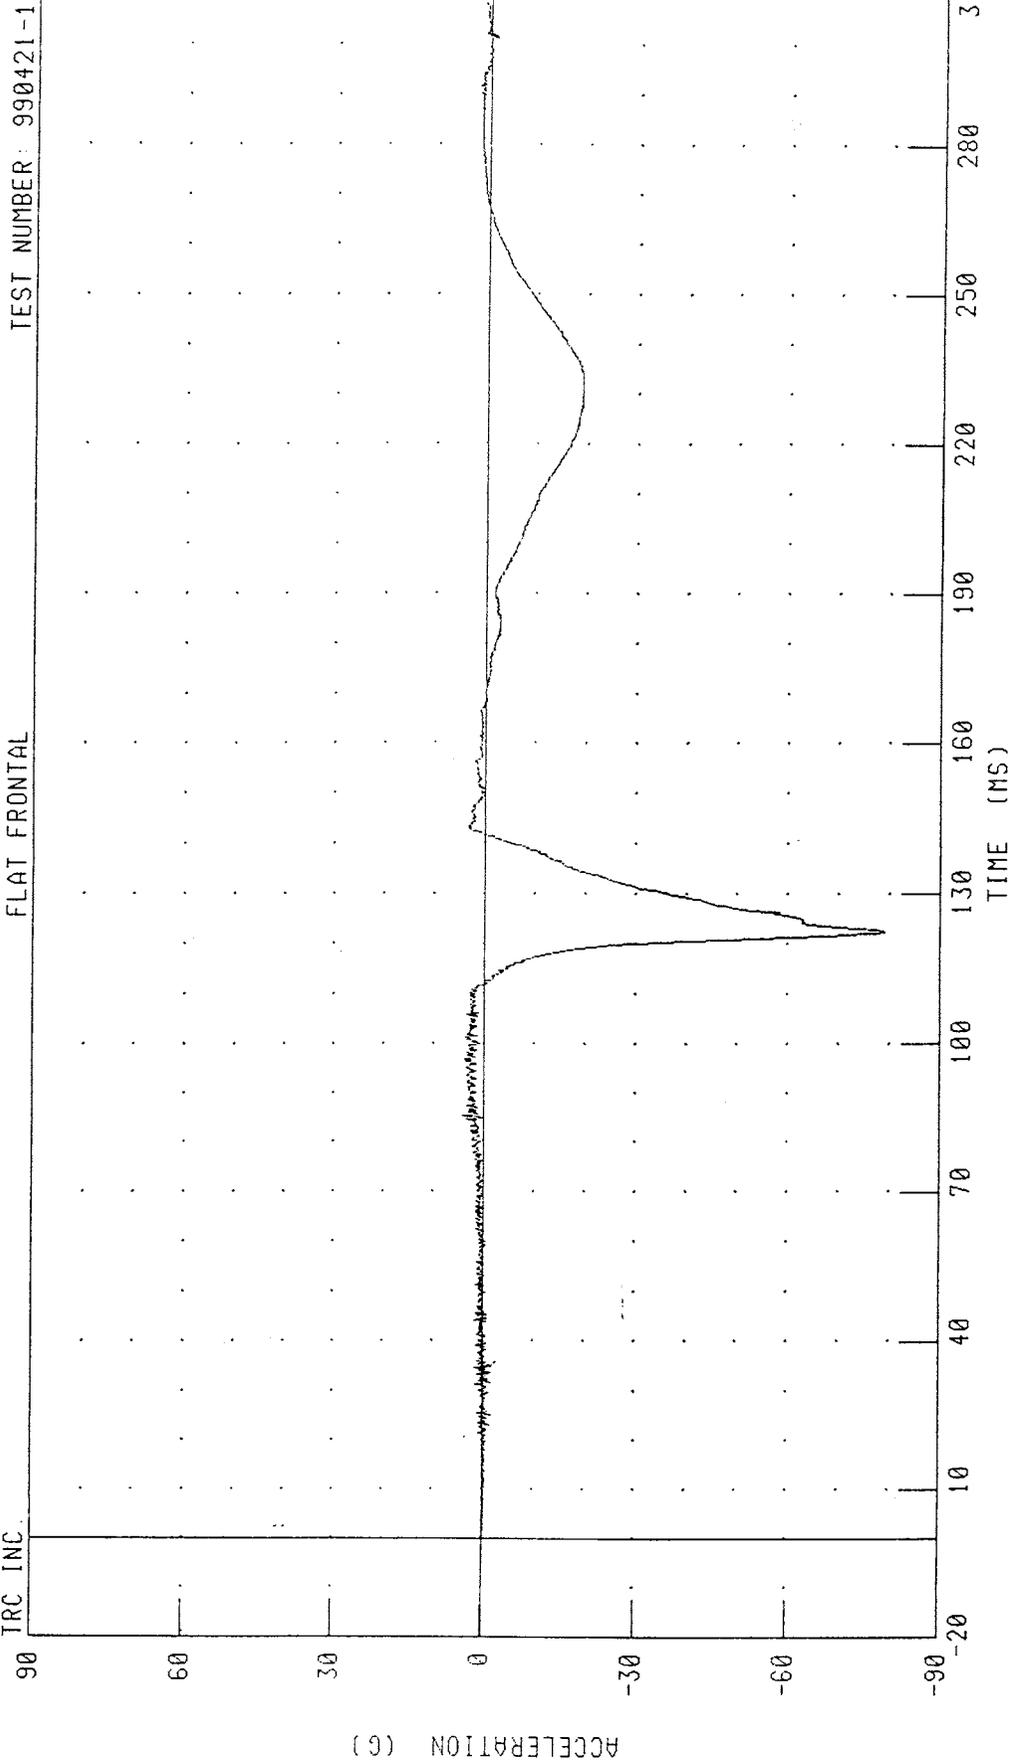
1997 THOMAS BUILT BUS INTO FLAT FRONTAL BARRIER  
POSITION # 1 HEAD X-AXIS ACCELERATION

CHANNEL: HEDXG1 FILTER: CH. CLASS 1000

PEAK DATA: 4.12 G @ 85.28 MS, -79.01 G @ 122.56 MS

The Position #1 dummy's 36 milliseconds Head Injury Criteria (HIC) was 244. The Position #1 dummy's chest maximum resultant acceleration with three (3) milliseconds minimum duration was 26.0 g. The Position #1 dummy's chest deflection was 4 mm. The Position #1 dummy's left and right femur maximum compressive forces were 2704 N and 2708 N, respectively.

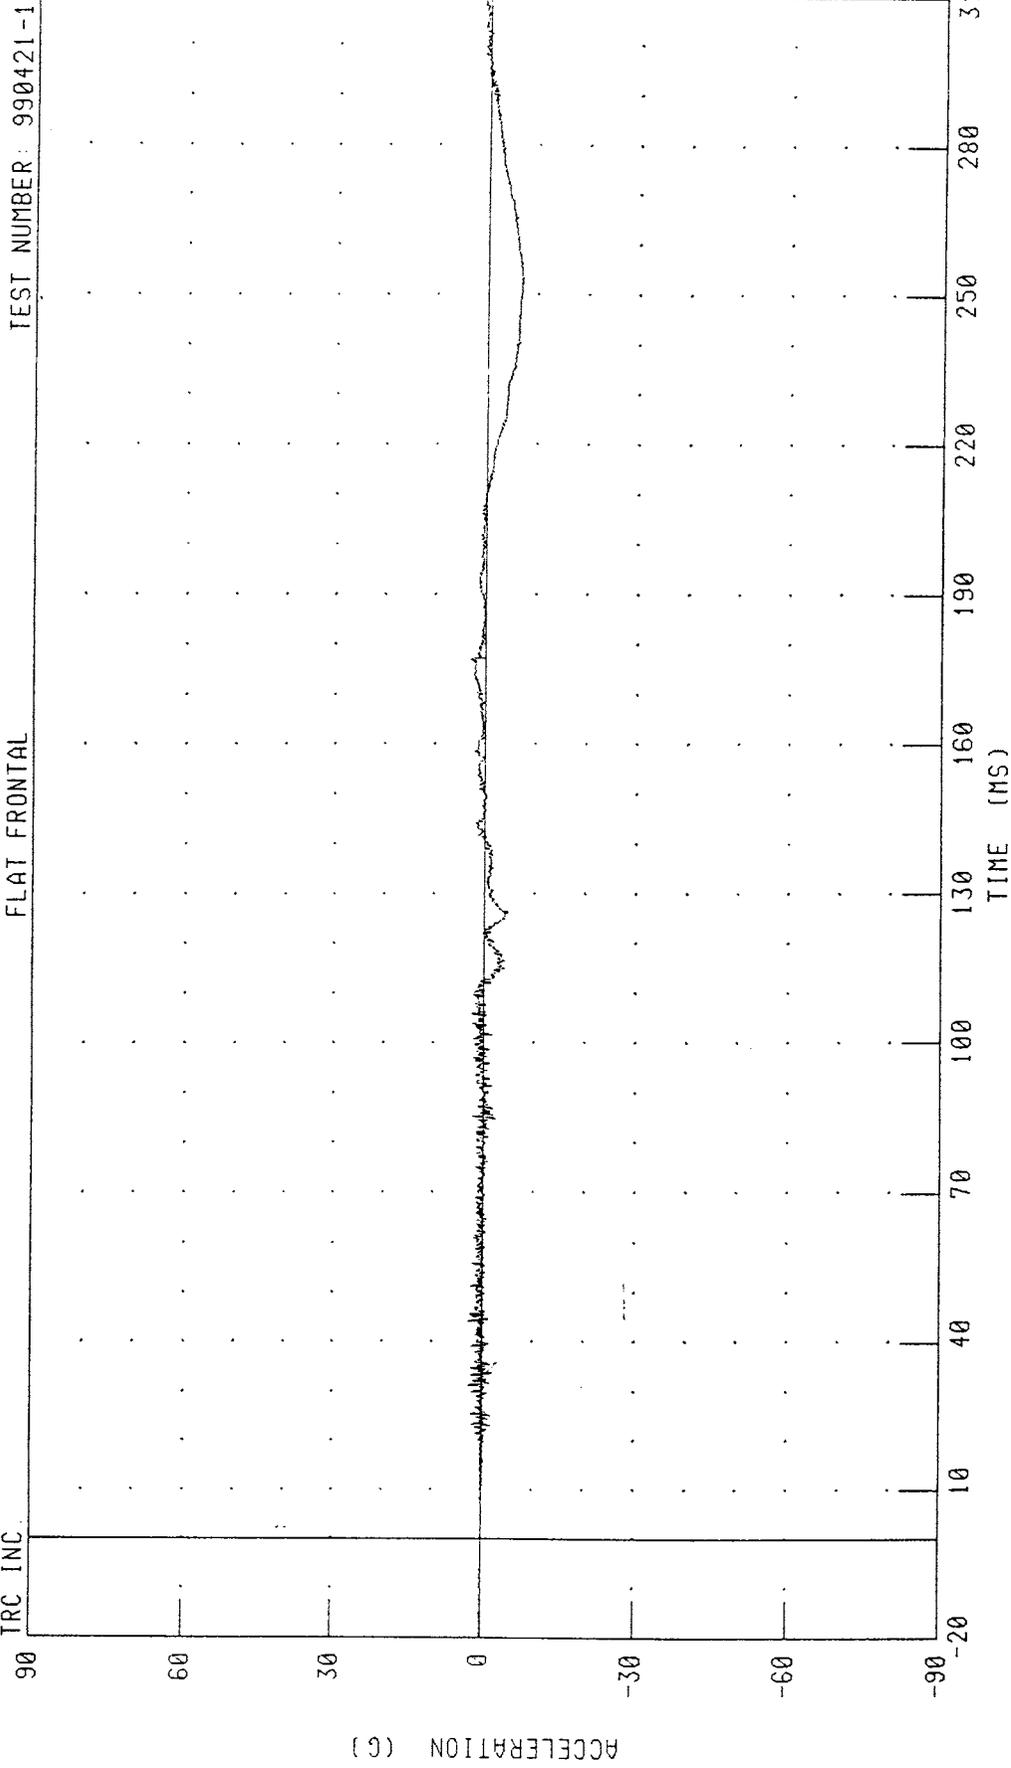
1997 THOMAS BUILT BUS INTO FLAT FRONTAL BARRIER  
POSITION # 1 HEAD Y-AXIS ACCELERATION

CHANNEL: HEDYG1 FILTER: CH. CLASS 1000

PEAK DATA: 2.85 G @ 177.04 MS, -6.93 G @ 250.72 MS

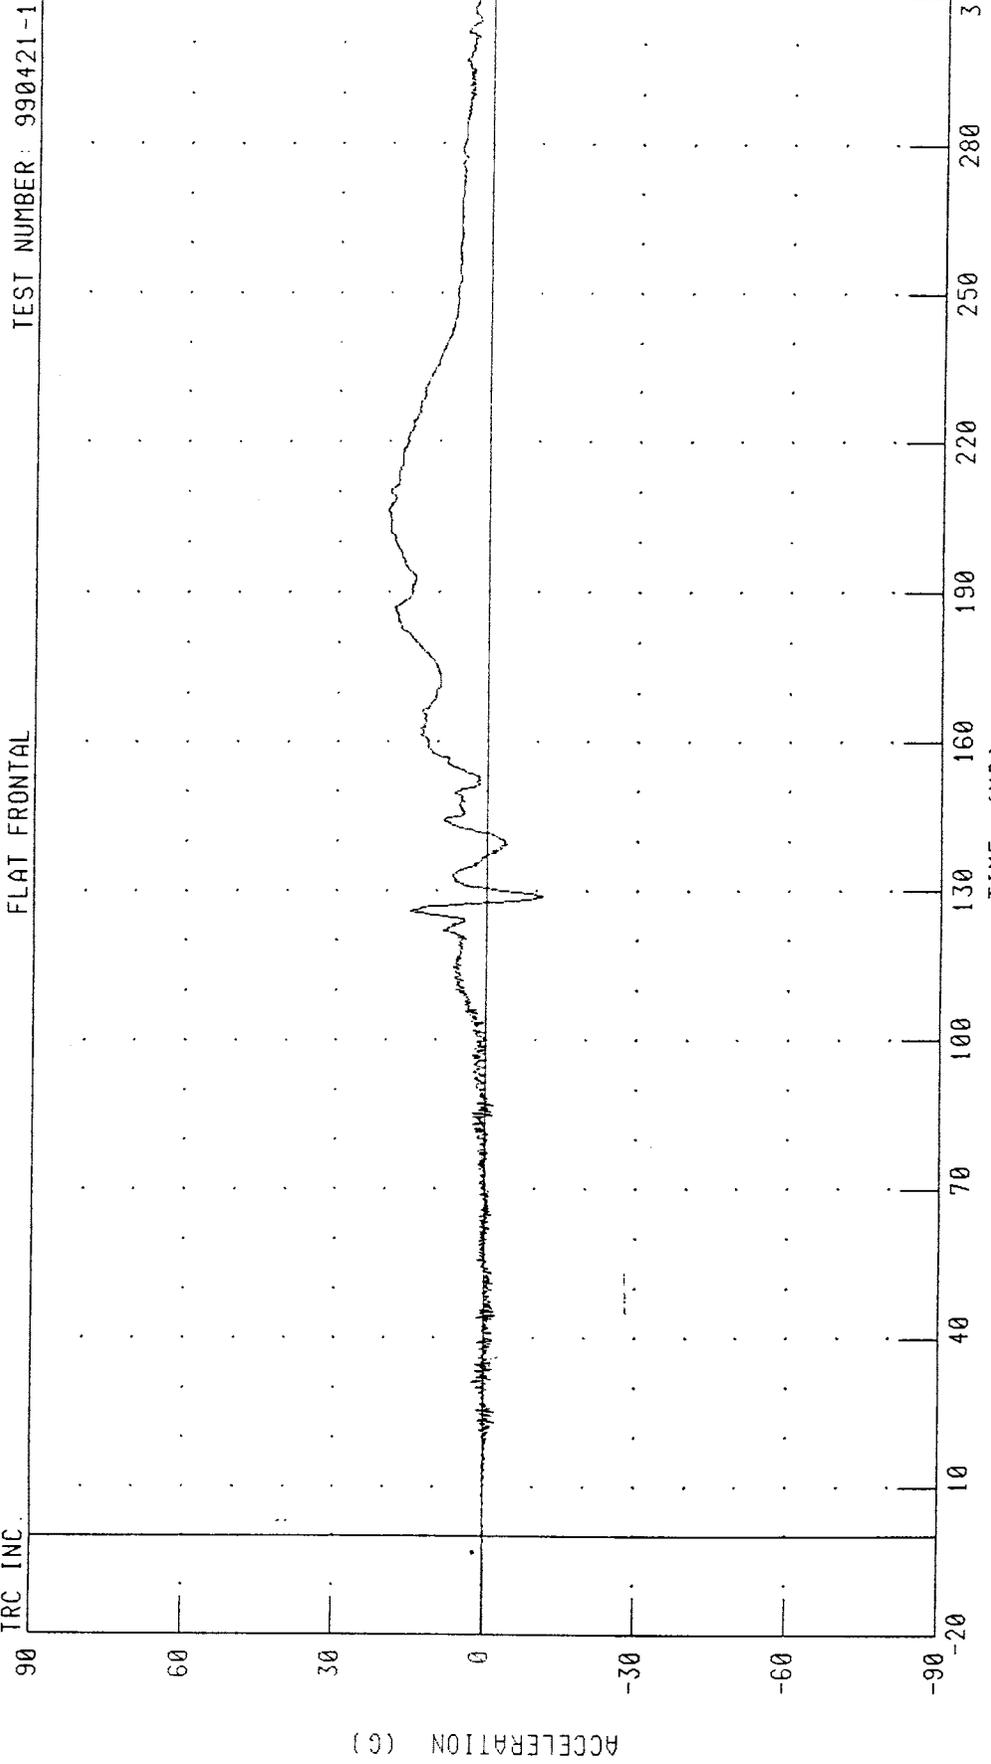
1997 THOMAS BUILT BUS INTO FLAT FRONTAL BARRIER  
POSITION # 1 HEAD Z-AXIS ACCELERATION

CHANNEL: HEDZG1 FILTER: CH. CLASS 1000 PEAK DATA: 20.18 G @ 206.00 MS, -11.17 G @ 128.96 MS

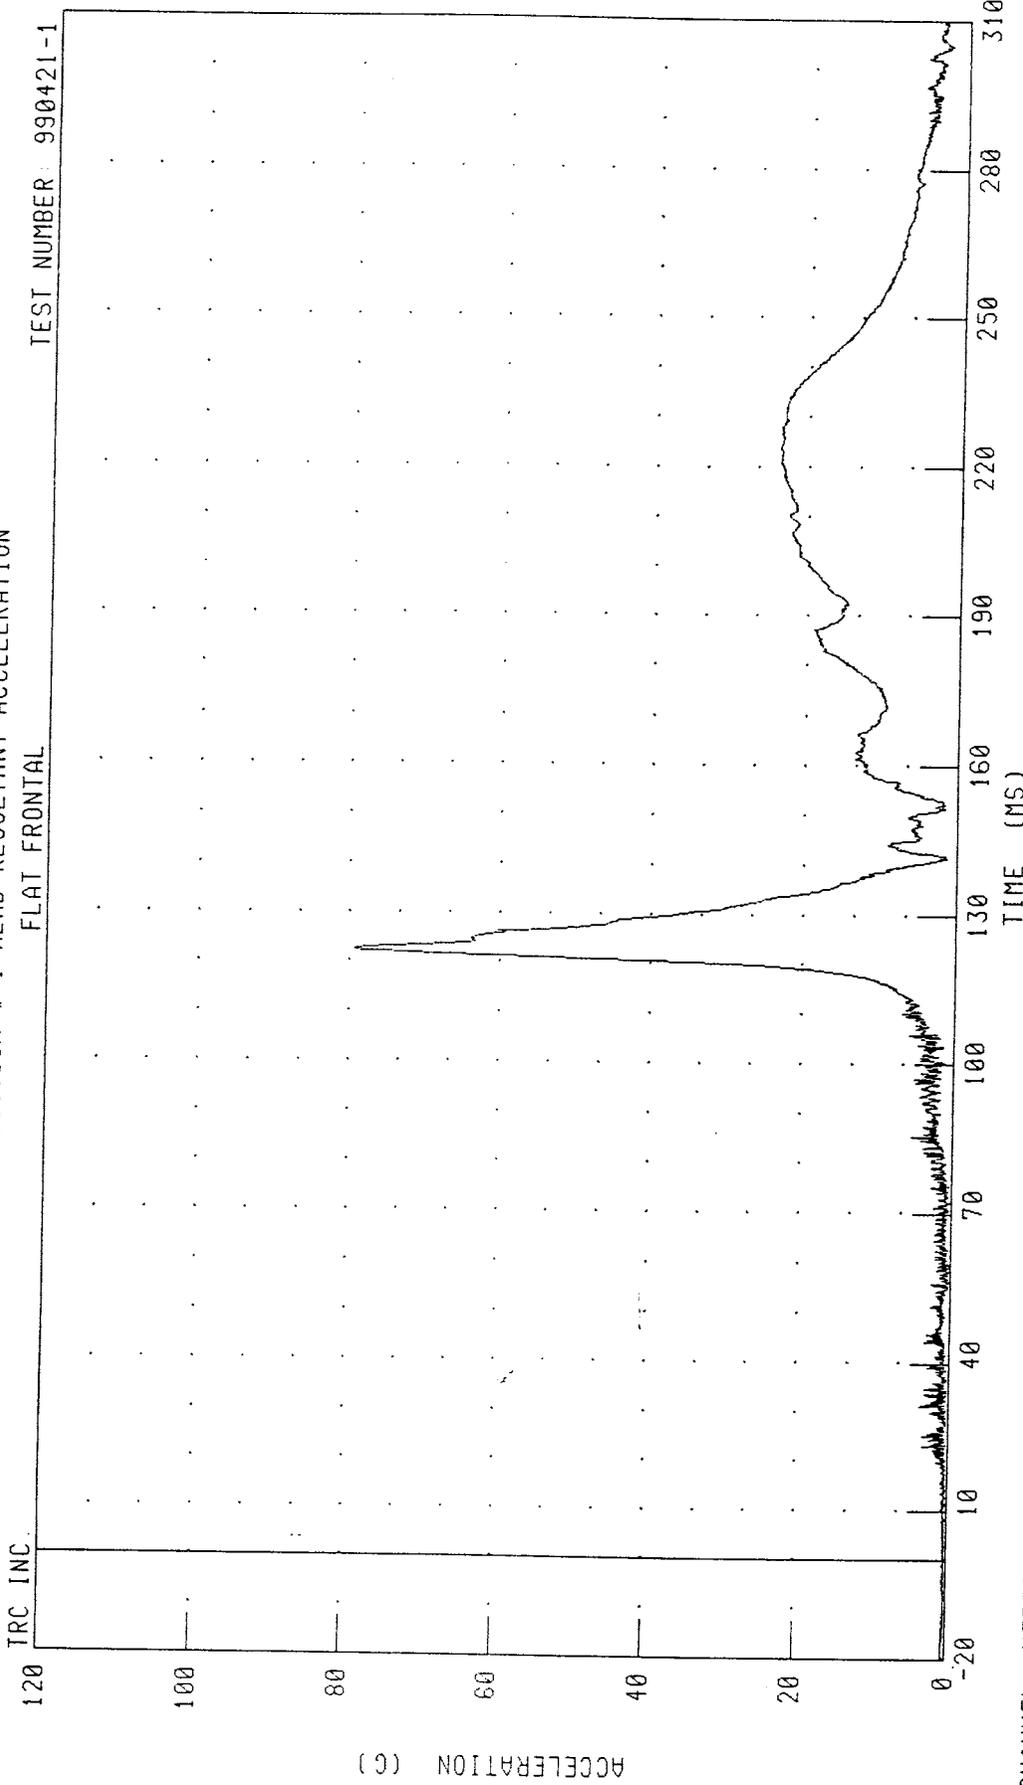
1997 THOMAS BUILT BUS INTO FLAT FRONTAL BARRIER  
POSITION # 1 HEAD RESULTANT ACCELERATION

CHANNEL: HEDRC1 FILTER: CH. CLASS 1000

PEAK DATA: 79.40 G @ 122.56 MS; 0.13 G @ 56.40 MS

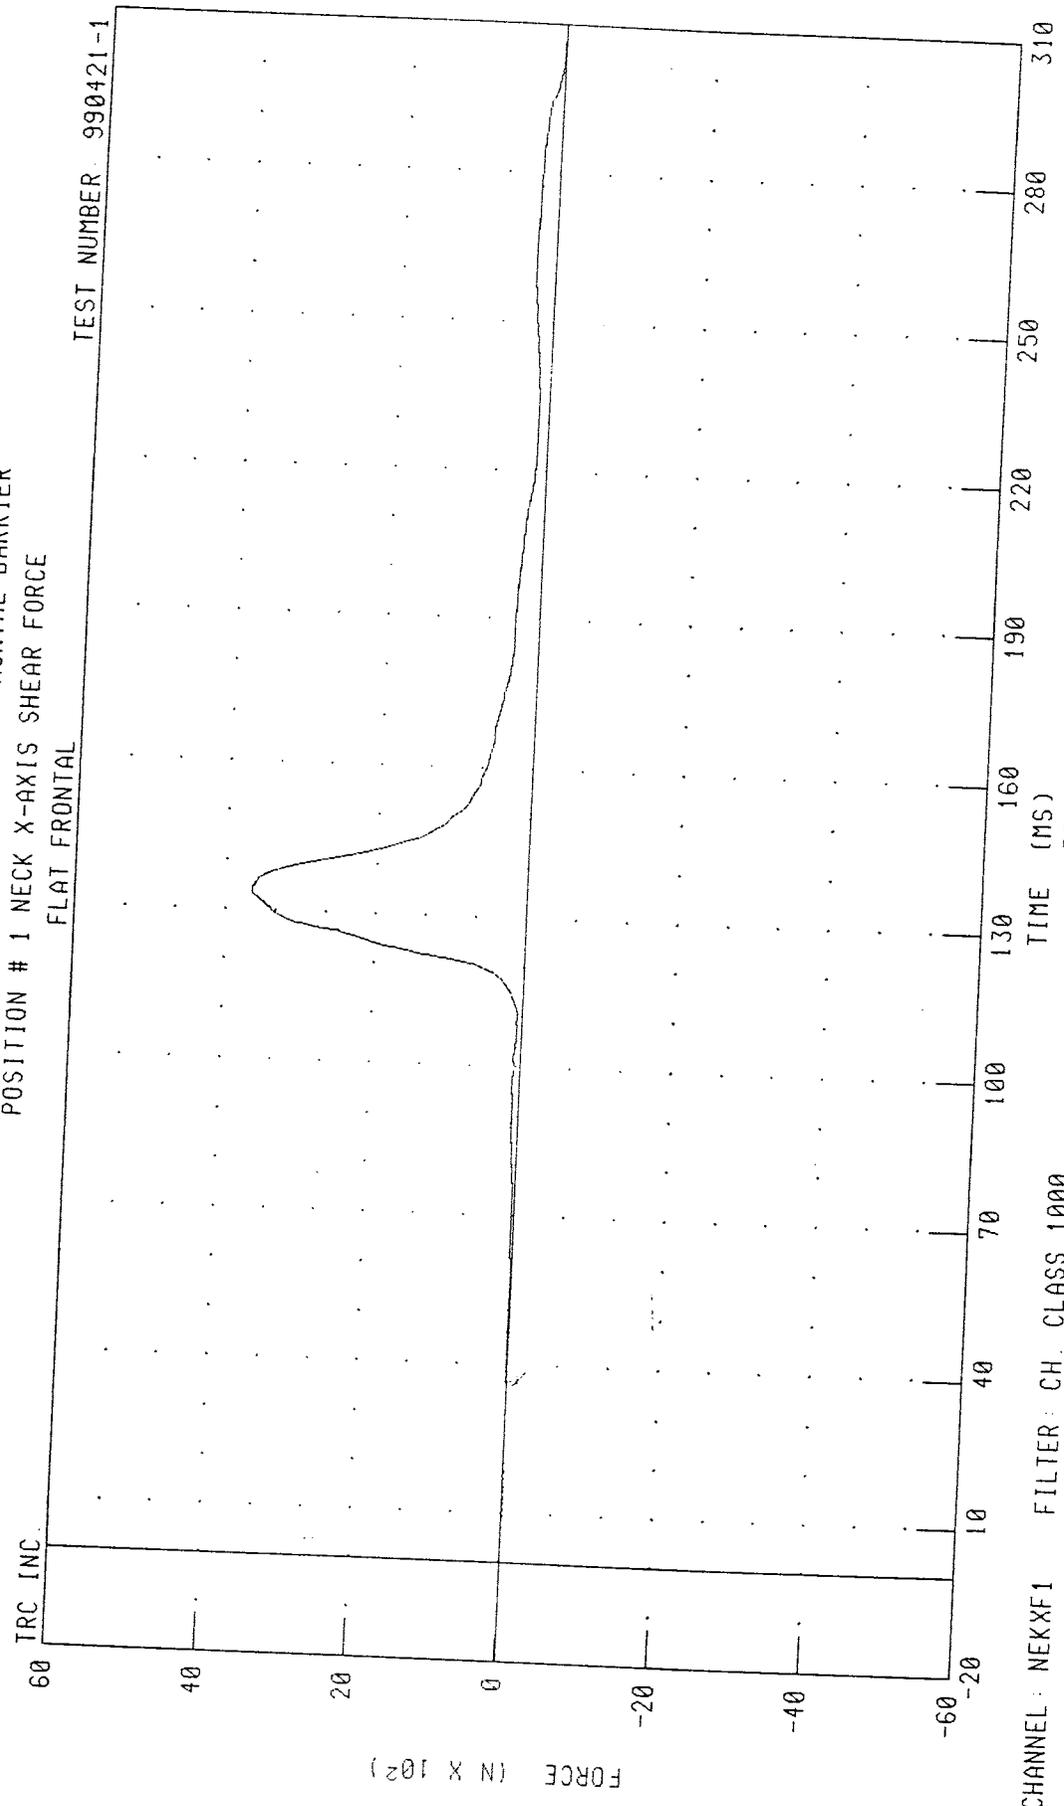
1997 THOMAS BUILT BUS INTO FLAT FRONTAL BARRIER  
POSITION # 1 NECK X-AXIS SHEAR FORCE  
FLAT FRONTAL

PEAK DATA: 3657.63 N @ 133.76 MS, -18.50 N @ 7.04 MS

CHANNEL: NEKXF1 FILTER: CH. CLASS 1000

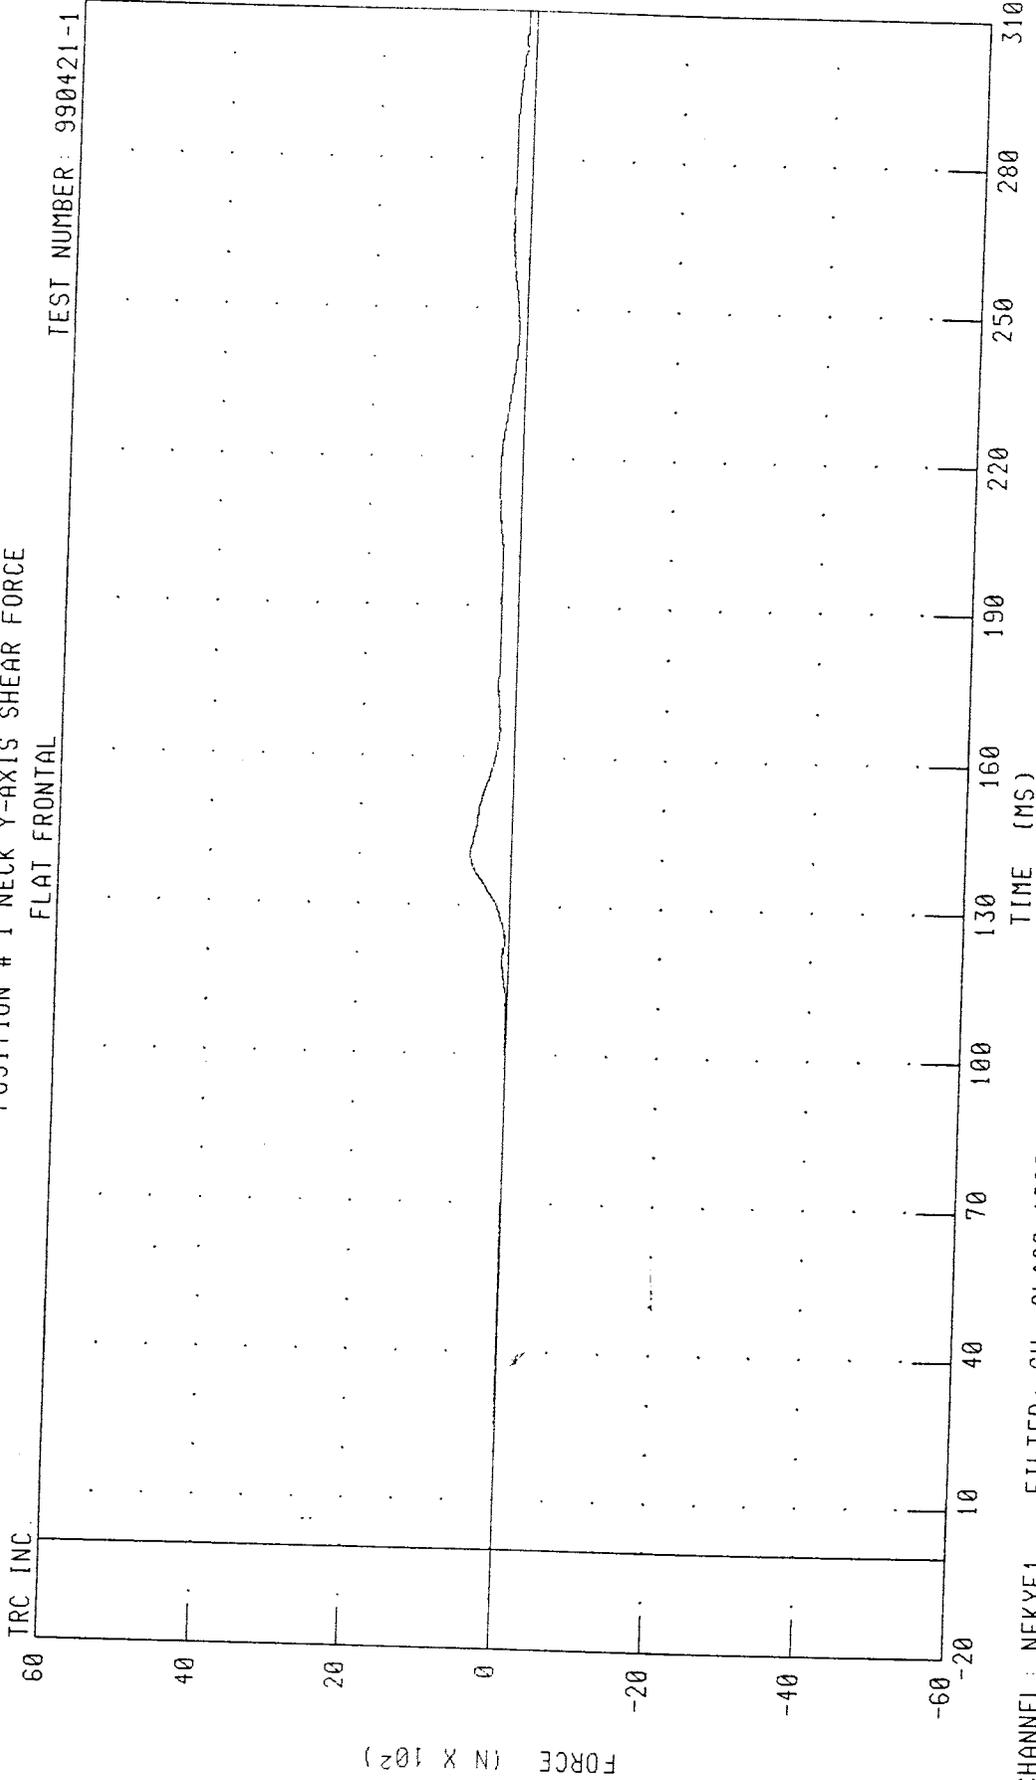
1997 THOMAS BUILT BUS INTO FLAT FRONTAL BARRIER  
POSITION # 1 NECK Y-AXIS SHEAR FORCE

CHANNEL: NEKYF1 FILTER: CH. CLASS 1000

PEAK DATA: 533.04 N @ 140.00 MS, -11.39 N @ 3.68 MS
